# OFFICIAL GEORGIA WOOD INFESTATION INSPECTION REPORT

Address of structure(s) 2846 Hollywood Drive, Decatur, GA 30033 (DeKalb County)

# DIAGRAM

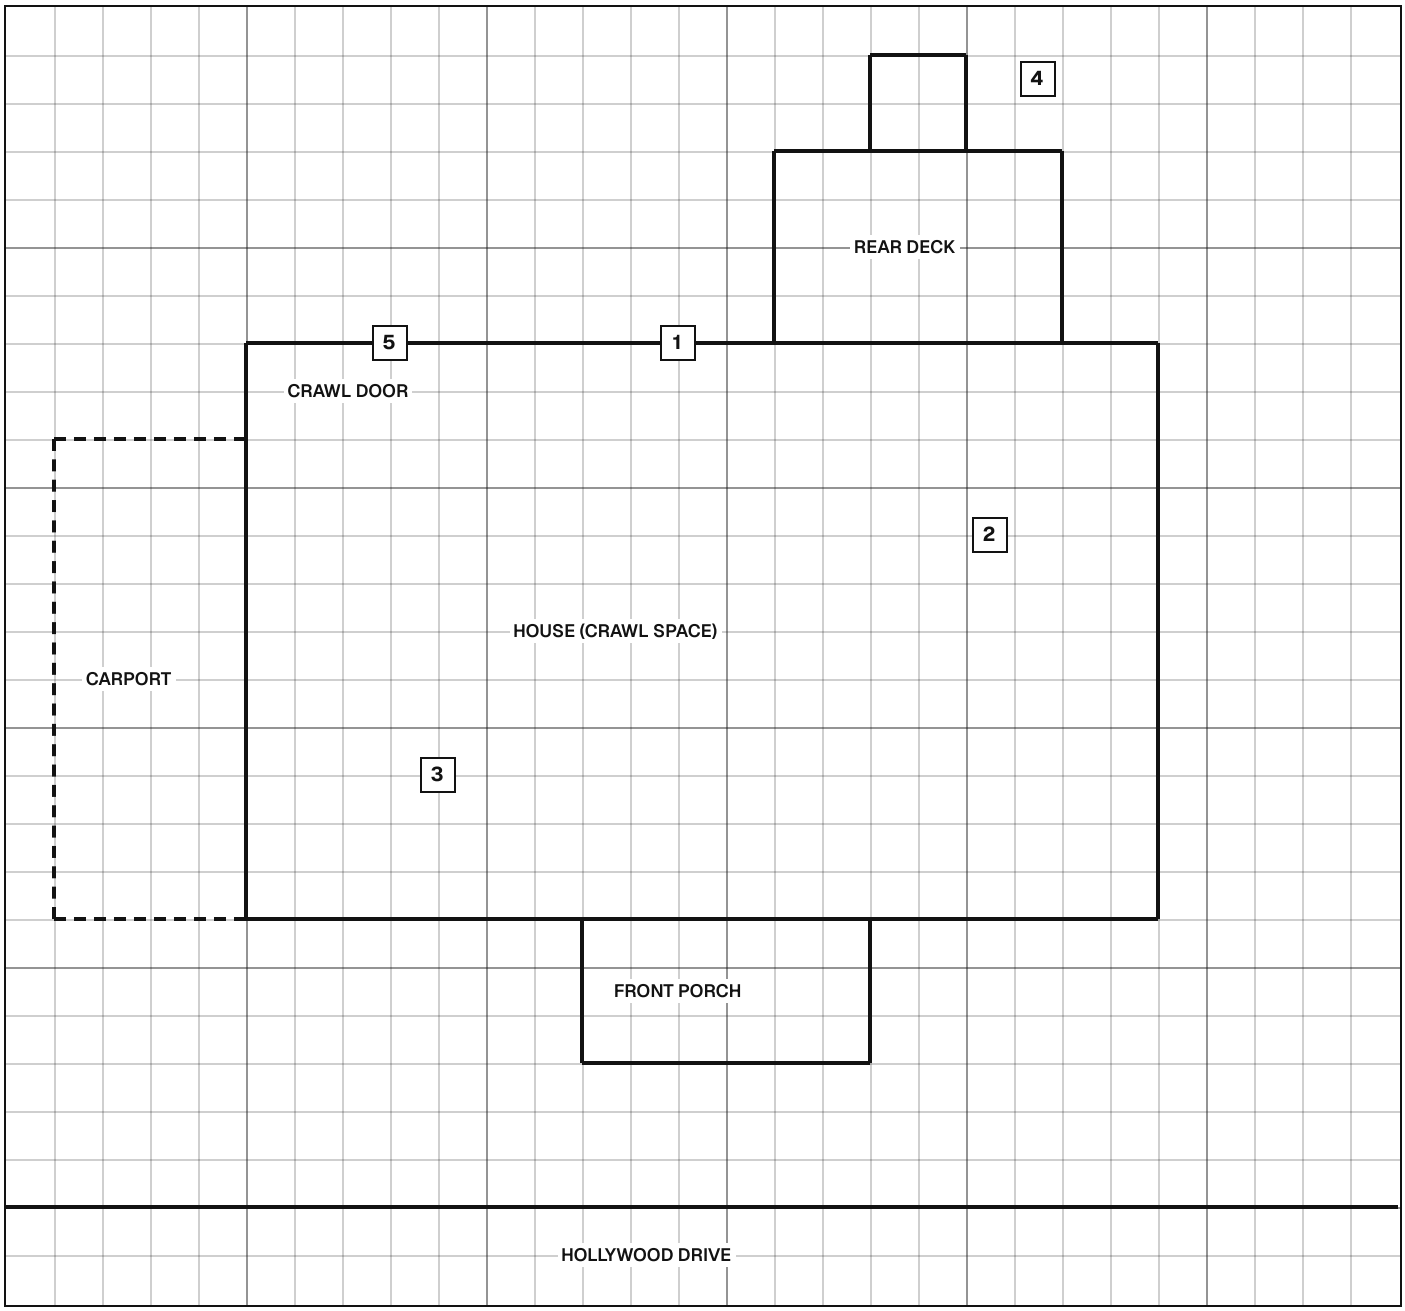
Wood debris (scrap lumber, old form boards) in crawl space. Earth to wood contact: rear deck stair stringers

and the wooden crawl space door frame at the rear. See marks 3, 4, and 5 on the attached diagram.

Remarks/Additional Findings: Active termites in rear foundation wall and sill plate behind hall bath (mark 1).

Old, empty mud tubes on a pier under the kitchen (mark 2). The attached diagram is an integral part of this report.

1. Active termites: live termites and mud tubes on rear foundation wall behind hall bath, and in sill plate above it
2. Previous termites: old, empty mud tubes on a brick pier under the kitchen. No live termites found there
3. Conducive: wood debris (scrap lumber, old form boards) on the crawl space soil
4. Conducive: rear deck stair stringers in contact with the soil
5. Conducive: wooden crawl space door frame in contact with the soil
6.
