TEXAS OFFICIAL WOOD DESTROYING INSECT REPORT

4107 Avenue F	Austin	78751
Inspected Address	City	Zip Code

1A. Live Oak Termite & Pest — Name of Inspection Company

1F. 09/11/2026 — Inspection Date

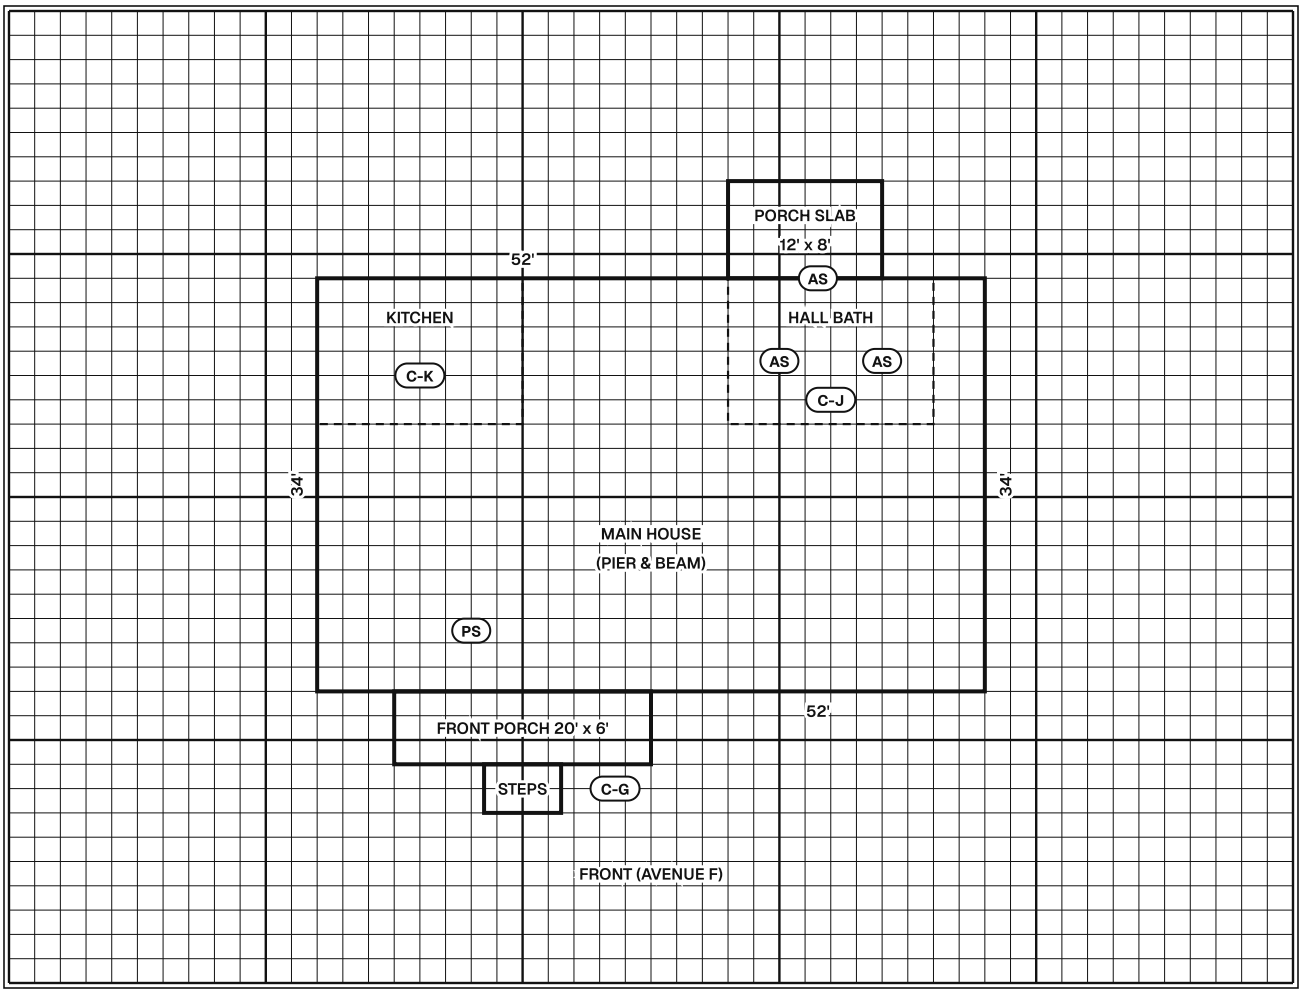
Diagram of Structure(s) Inspected

Wood to Ground Contact (G)	☑	Formboards left in place (I)	☐	Excessive Moisture (J)	☑
Debris under or around structure (K)	☑	Footing too low or soil line too high (L)	☐	Wood Rot (M)	☐	Heavy Foliage (N)	☐
Planter box abutting structure (O)	☐	Wood Pile in Contact with Structure (Q)	☐	Wooden Fence in Contact with the Structure (R)			☐
Insufficient ventilation (T)	☐	Other (C) ☐		Specify:	G: wood front steps rest on soil. J: tub drain leak under hall bath.

J: damp soil under the tub drain, and the sill plate there read 28% on a moisture meter. K: scrap lumber in crawl space under kitchen.

11G.Visible evidence of: Subterranean termites, active and old has been observed in the following areas: Two piers and the sill under the hall bath, and the rear sill at the porch slab (active). Old dry tubes on one front pier (previous). See diagram.

Additional Comments Live subterranean termites in active mud tubes on two piers and the sill plate under the hall bath,

and on the rear sill plate where the concrete porch slab meets the house. Old dry tubes on one front pier.

No visible evidence of a prior treatment. Damage seen at the hall bath sill. Extent not determined (Scope Part E).

Specify reason: Correct conducive conditions G, J, and K: lift front steps off soil, repair tub drain leak, remove scrap lumber.

Written estimate with treatment diagram, pesticide label, and warranty details to follow (Scope Part G).
