OFFICIAL ALABAMA WOOD INFESTATION INSPECTION REPORT -- Part A
(Report Consists of Part A and Part B)

☑ Main Structure Only 1967 one-story brick ranch on crawl space Other Structures (Specify) None

Address of Structure(s) 3127 Woodley Road, Montgomery, AL 36111

OFFICIAL ALABAMA WOOD INFESTATION INSPECTION REPORT -- Part B

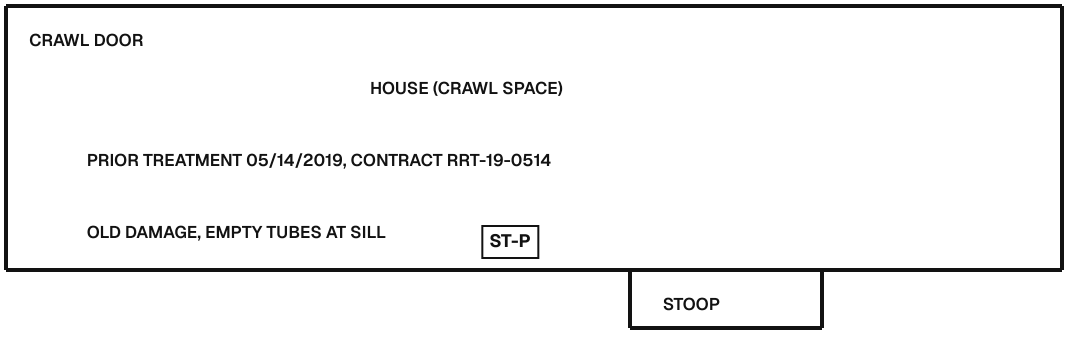
DIAGRAM

Remarks/Additional Findings Old subterranean termite damage and empty mud tubes at front sill plate, left of front door (crawl space side).

No live termites or active tubes found. Area was treated 05/14/2019 under our contract and has been inspected yearly.

ACTIVE	PREVIOUS		
☐	☑	SUBTERRANEAN TERMITES	Front sill plate, left of front door (old damage, empty tubes; treated 2019)
☐	☐	POWDER POST BEETLES	
☐	☐	WOOD BORING BEETLE	
☐	☐	DRY WOOD TERMITES	
☐	☐	WOOD DECAYING FUNGI

Damage should be evaluated by a qualified building expert. See diagram on Part B.
