TERMITE REINSPECTION REPORT

Street address	City	State / ZIP	Date of reinspection	Pages
5604 Gloster Road	Bethesda	MD 20816	10/20/2026	2

Report No. 26-1047
MDA license No. 34127
County Montgomery

Updated Inspection Diagram

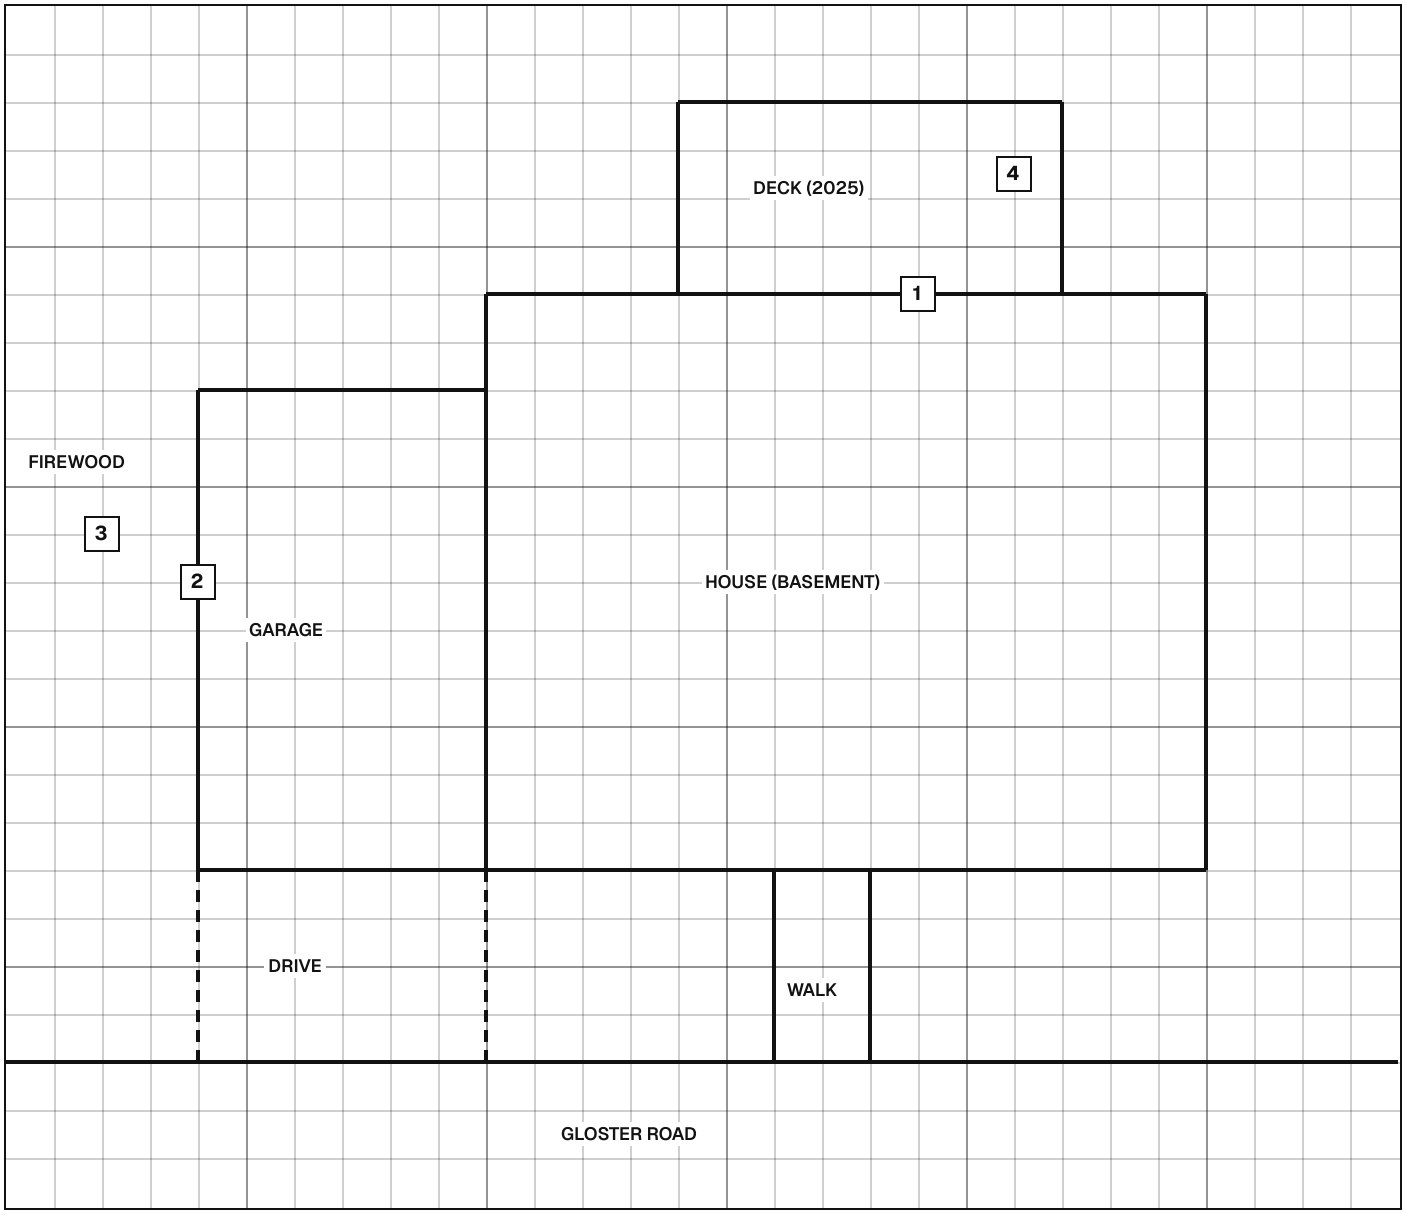
Wood destroying insects or visible evidence, and where
Live subterranean termites in new shelter tubes on the garage's left foundation wall, 6 ft from the front.

Visible damage, and whether it has been or will be corrected
None visible. The garage sill sounded solid when probed. No new activity at the 2023 rear wall area.

Conditions conducive to infestation
Firewood stacked against the garage's left wall, and mulch over the foundation line in the front beds.

What changed on the diagram
Added the 2025 deck (mark 4), the new garage tubes (mark 2), and the firewood (mark 3).

1	2023: live termites at the rear basement wall, treated 06/20/2023. No new activity found
2	New 10/20/2026: live shelter tubes on the garage's left foundation wall, up to the sill plate. Treated
3	New 10/20/2026: firewood stacked against the garage's left wall (conducive condition)
4	New 10/20/2026: deck added in 2025. Inspected from below, no evidence found
5	
6

Pesticide (common name or active ingredient)	EPA Reg. No.	Area treated	Amount used
Termidor SC Fipronil 9.1%	7969-210	Garage, left wall: 12 linear ft trenched and rodded, slab drilled along the wall	6 gal at 0.06%
